METALS HANDBOOK

VOL. 9
FRACTOGRAPHY AND ATLAS OF FRACTOGRAPHY

8th EDITION

Fractography and Atlas of Fractographs

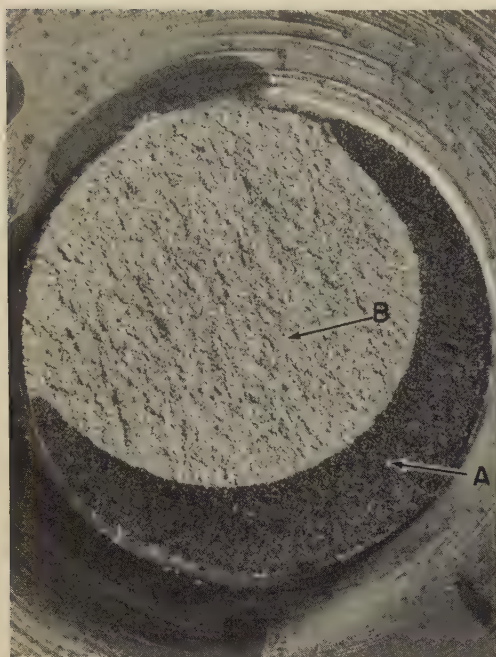
Light fractograph 5×
4321 Impact fracture in 4340 steel machined to a 2-in.-diam, 1½-in.-long cylinder with a ½-in.-diam, 1-in.-long central projection from one end. Specimen was heat treated ¼ hr at 816 C (1500 F) and water quenched, but not tempered; then the projection was broken by hammer blow. The dark crescent (A) is a quench crack; light area (B) is the impact fracture. See 4322-4326.

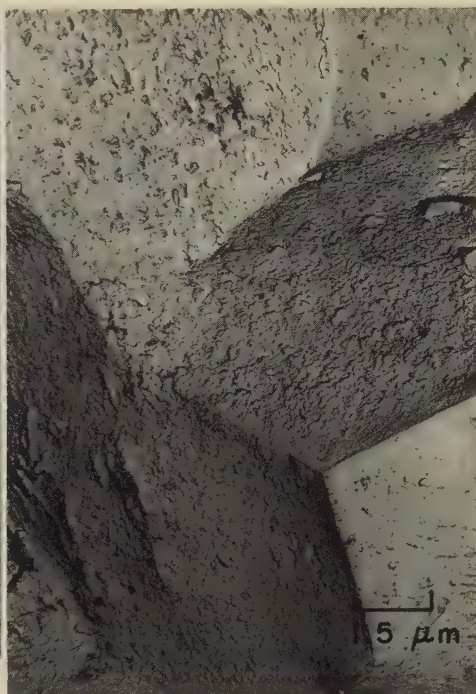
TEM fractograph (p-c replica) 6500×
4322 A TEM replication taken from area A (the quench-crack crescent) in the fracture surface shown in fractograph 4321. Here, the crack is completely intergranular in nature, having faithfully followed the grain interfaces. Traces of oxidation are evident. See 4323, 4324.

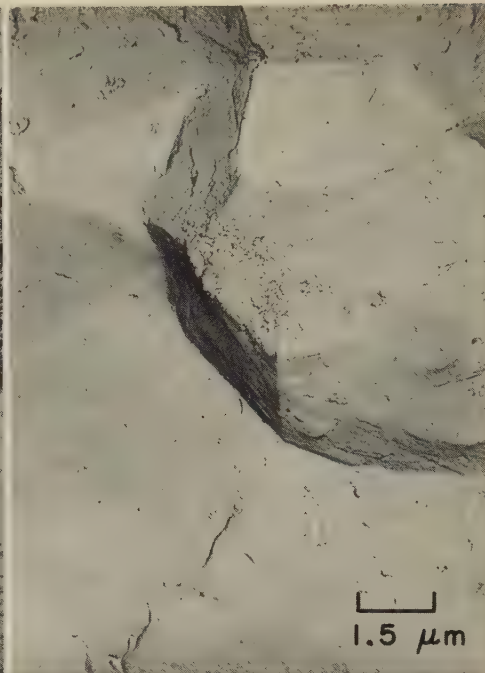
TEM fractograph (p-c replica) 6500×
4323 TEM replication from a different region in area A (quench-crack crescent) in the fracture surface in 4321. Here, as in 4322, the crack path has been along the grain interfaces. Scattered marks here resemble the hairline indications associated with either hydrogen embrittlement or stress-corrosion cracking.

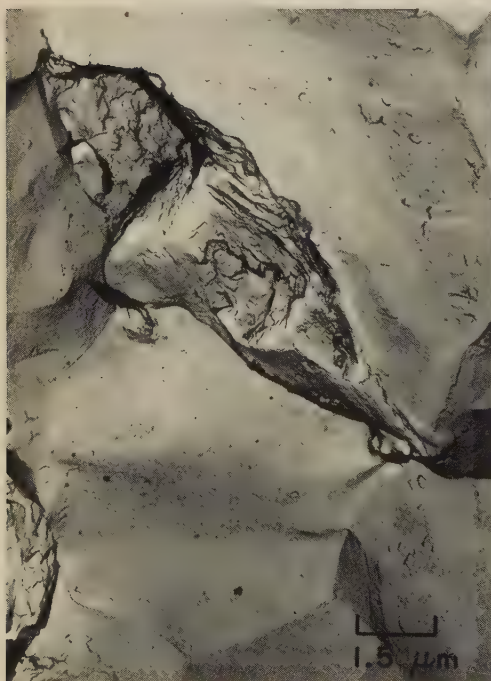
TEM fractograph (p-c replica) 6500×
4324 A TEM replication taken near the root of the quench crack, marked A, in fractograph 4321. In addition to separated-grain facets, localized regions of transgranular tearing are visible. The grain facets are clean of oxidation, although they display a few hairline indications.

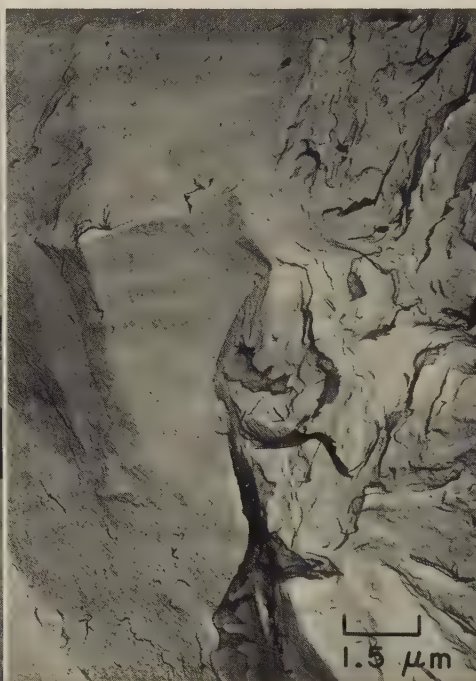
TEM fractograph (p-c replica) 6500×
4325 A TEM replication taken at the root of the quench crack, marked A, in 4321, and the beginning of the impact fracture, marked B there. At left are the last vestiges of intergranular cracking, and at right is the beginning of quasicleavage cracking in this very brittle specimen.

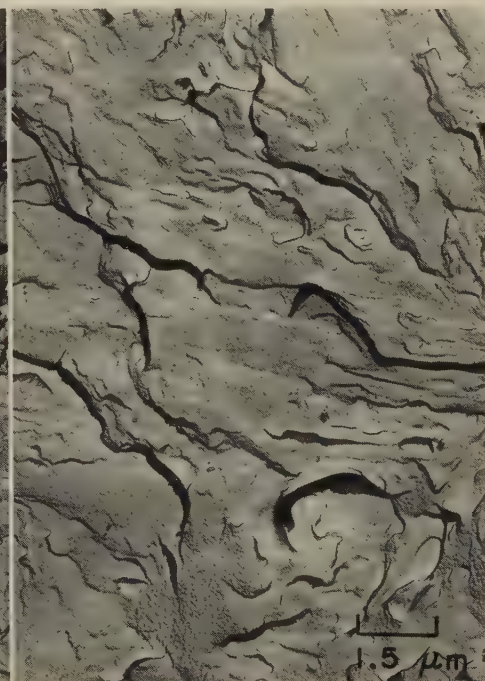
TEM fractograph (p-c replica) 6500×
4326 TEM replica from deep within the impact-fracture area, B, in 4321, showing the quasicleavage characteristics of this brittle, untempered specimen. No large facets are visible; this suggests that the specimen had a fine grain size. Many steps exist in the crack path.

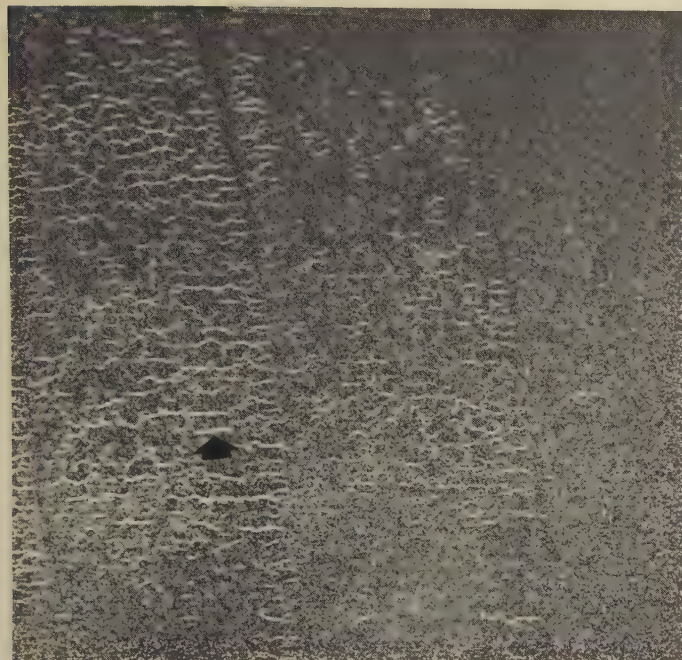
Macrograph (etchant: 5% nital) 10×

4327 The surface of 4340 steel that was heat treated to a tensile strength of 1793 to 1931 MPa (260 to 280 ksi), showing a network of grinding cracks. These cracks can produce serious stress concentrations leading to early fracture. See 4328 to 4330 for fractures associated with grinding cracks.

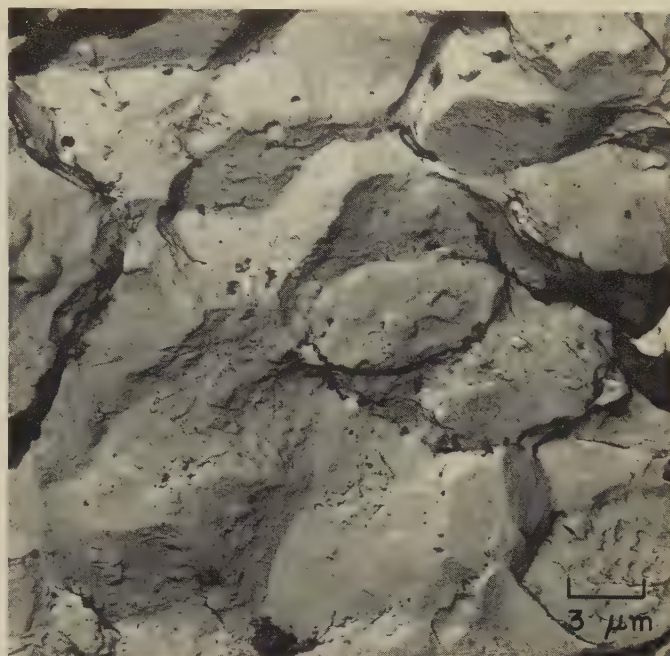
TEM fractograph (p-c replica) 3300×

4328 A typical fracture surface arising from rupture of a 4340 steel part possessing grinding cracks such as those shown in macrograph 4327, at left. Both intergranular and transgranular facets are evident; some of the facets show fine dimples. See also fractographs 4329 and 4330, below.

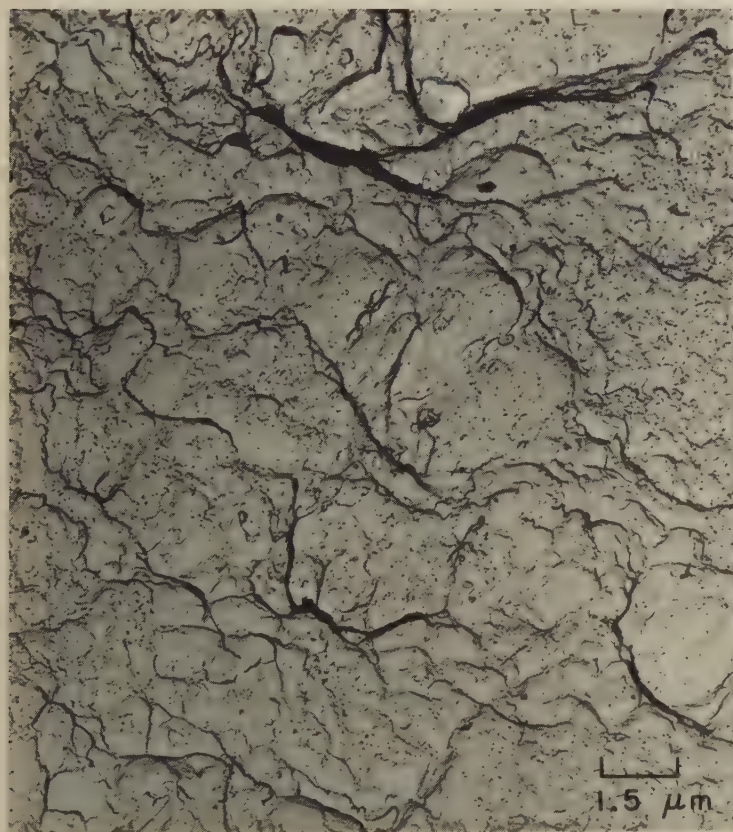
TEM fractograph (p-c replica) 6500×

4329 Surface of a fracture in an aircraft nose-landing-gear cylinder made of 4340 steel and heat treated to a tensile strength of 1793 to 1931 MPa (260 to 280 ksi). The surface bears iron oxide resulting from corrosion in grinding cracks. Dimples and a few distinct grain boundaries are present.

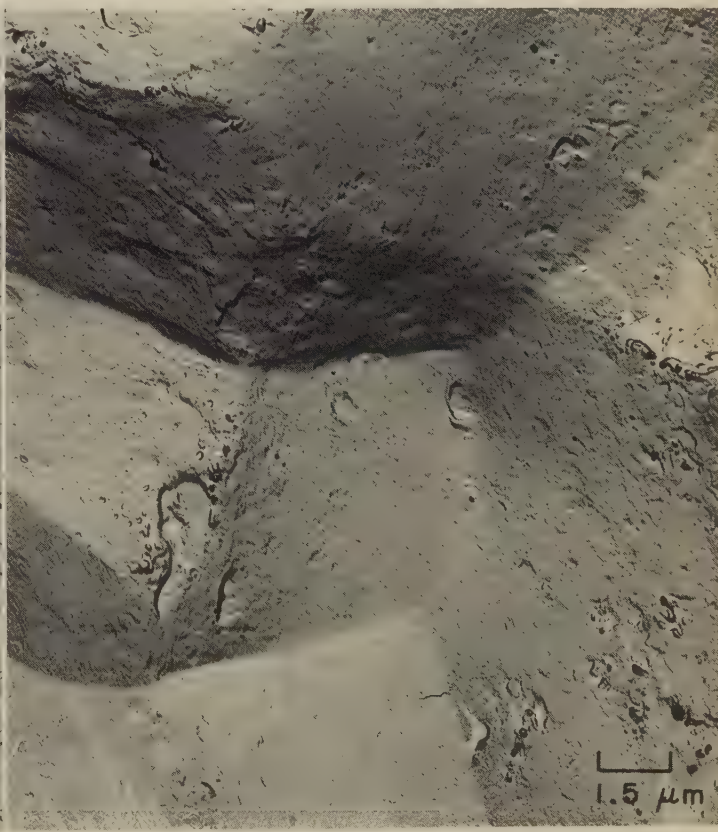
TEM fractograph (p-c replica) 6500×

4330 The surface of a crack found beneath chromium plating on a pivot bolt of 4340 steel that was heat treated to a tensile strength of 1793 to 1931 MPa (260 to 280 ksi). Grinding cracks were found in this area, but the completely intergranular nature of this surface suggests subsequent stress corrosion.

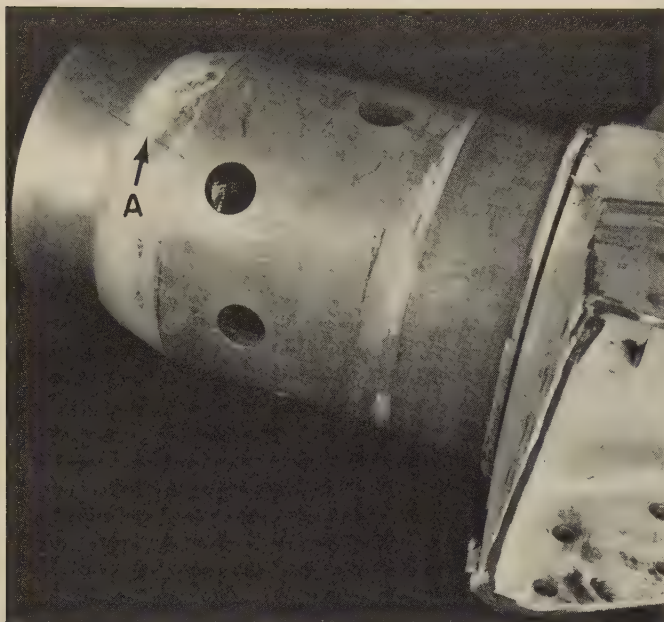
Photograph

4331 View of an aircraft horizontal tail-actuator shaft that was found during a preflight inspection to contain several cracks (one is shown at A). The shaft was forged from 4340 steel, was heat treated to a minimum tensile strength of 1793 MPa (260 ksi) and a hardness of Rockwell C 50 to 53, and then was vacuum cadmium plated. Cracks were attributed to hydrogen embrittlement. See also 4332 to 4340.

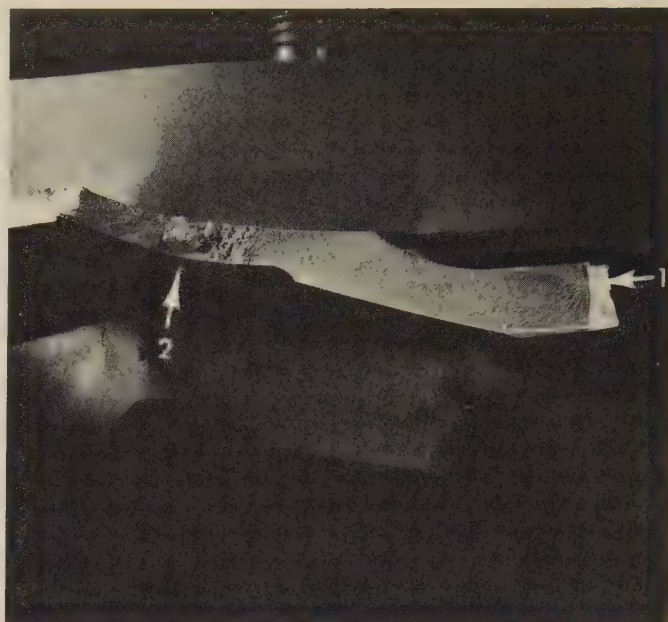
Light fractograph

4332 Surface of the crack visible at A in 4331, opened for examination, showing two internal points of crack nucleation, which are marked 1 and 2 and are shown at higher magnification in 4333 and 4334. Neither this crack nor any other crack found in this shaft or in companion shafts showed evidence of the corrosion products (red rust) that would be expected if stress corrosion had been involved.

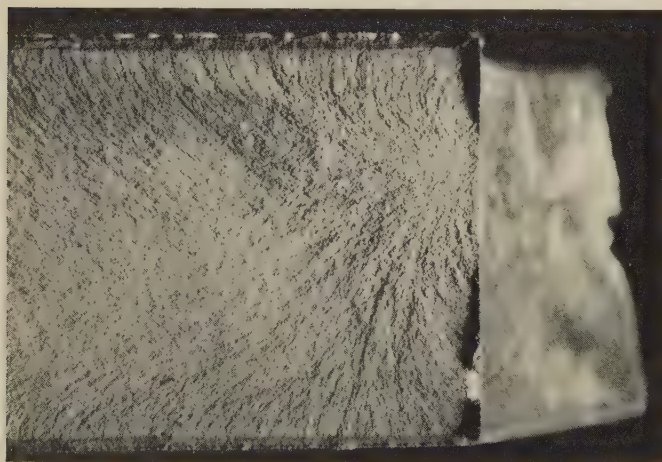
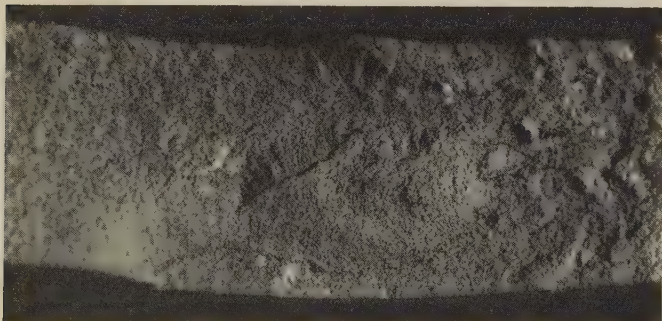
Light fractographs

4333 Enlarged views of the internal points of crack nucleation shown in 4332. In fractograph 4333 (above), which includes point 1, chevron marks indicate that direction of fracture was right to left; shear lips are present at the borders. Fractograph 4334 (below), which includes point 2, shows secondary cracking. See 4335-4337.

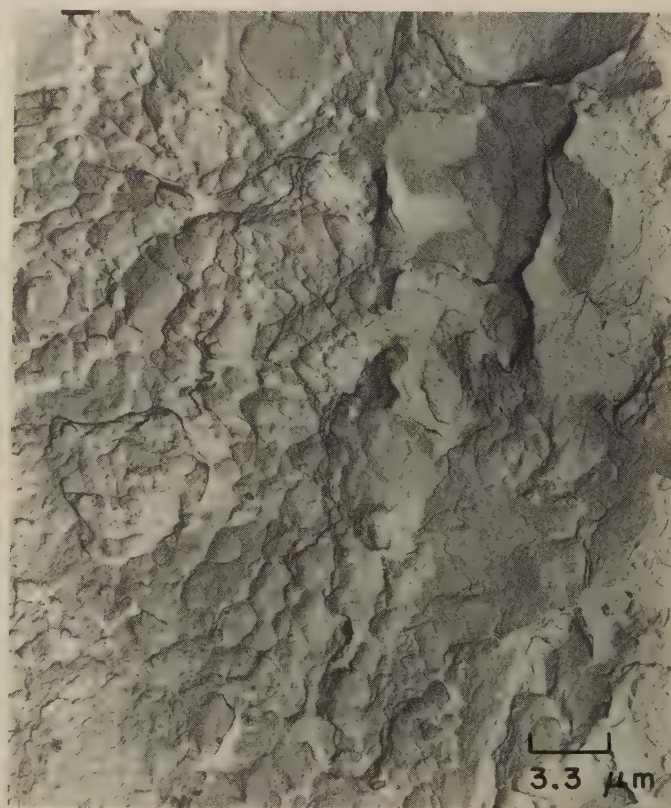
TEM fractograph (p-c replica)

4335 A TEM replica of a region near the right edge of the fracture surface in 4333, showing a transition from intergranular facets (at right) to dimples (at left). This transition is typical of all cracks in the actuator shaft that originated near holes; in each instance, transition occurred at 0.02 to 0.07 in. from the edge of the hole.

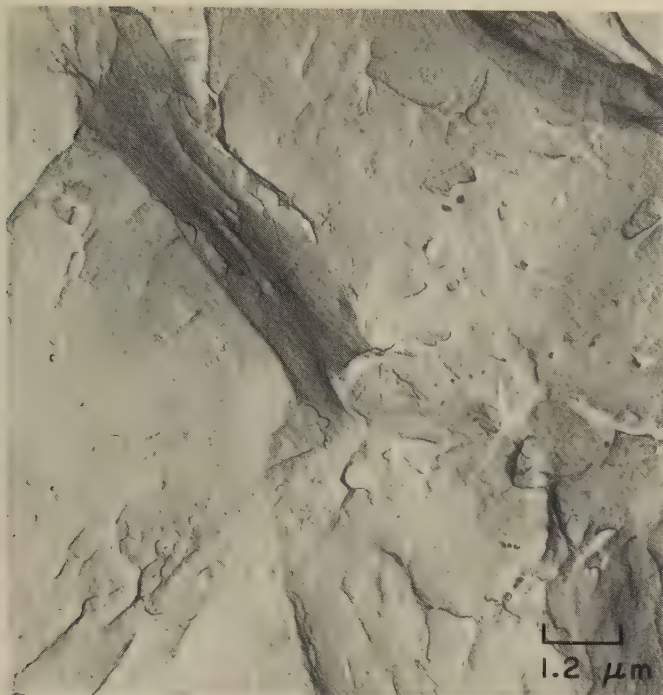
TEM fractograph (p-c replica)

4336 TEM replica of a region centered on the crack-nucleation point visible near the right edge of the fracture surface shown in 4333. The surface is intergranular and free of corrosion products, which is consistent with fracture caused by hydrogen embrittlement.

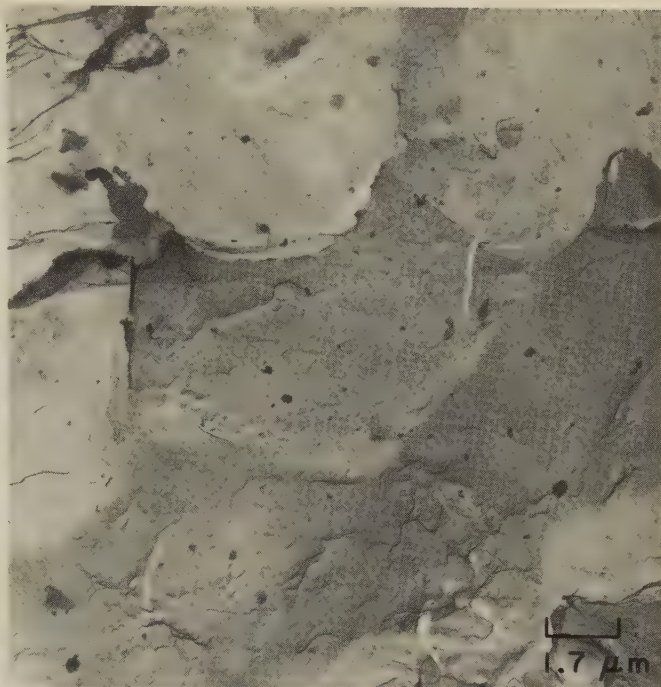
TEM fractograph (p-c replica)

4337 TEM replica of a region containing the crack-nucleation site near point 2 in fractograph 4332. The features that are visible in this region are the same as those in the region shown in 4336 (left), which further suggests that hydrogen embrittlement caused the cracks.

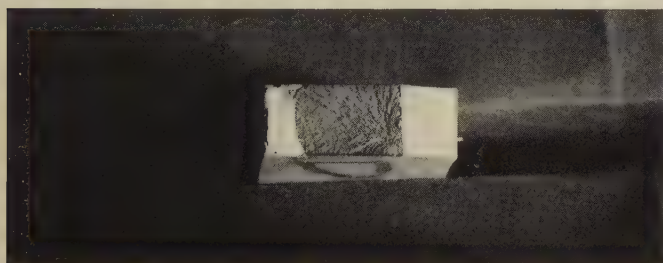
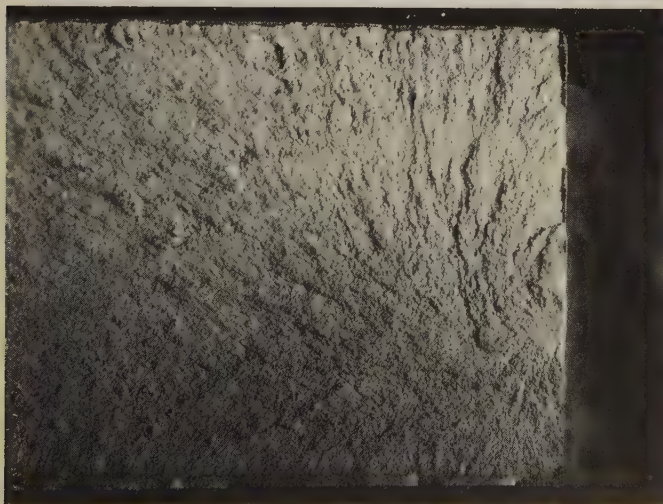
Light fractographs

4338 Views, at two magnifications, of a crack 135° around the shaft from the crack at A in 4331, opened for examination. Again, the point of crack nucleation was internal. The crack then propagated both inward and outward, as shown by the chevron marks and shear lips.

4340 TEM replica of a region containing a point of nucleation in a crack very similar to those shown in 4332 and 4339, in a companion actuator shaft. This surface shows all of the intergranular characteristics of fracture by hydrogen embrittlement seen in 4336 and 4337.

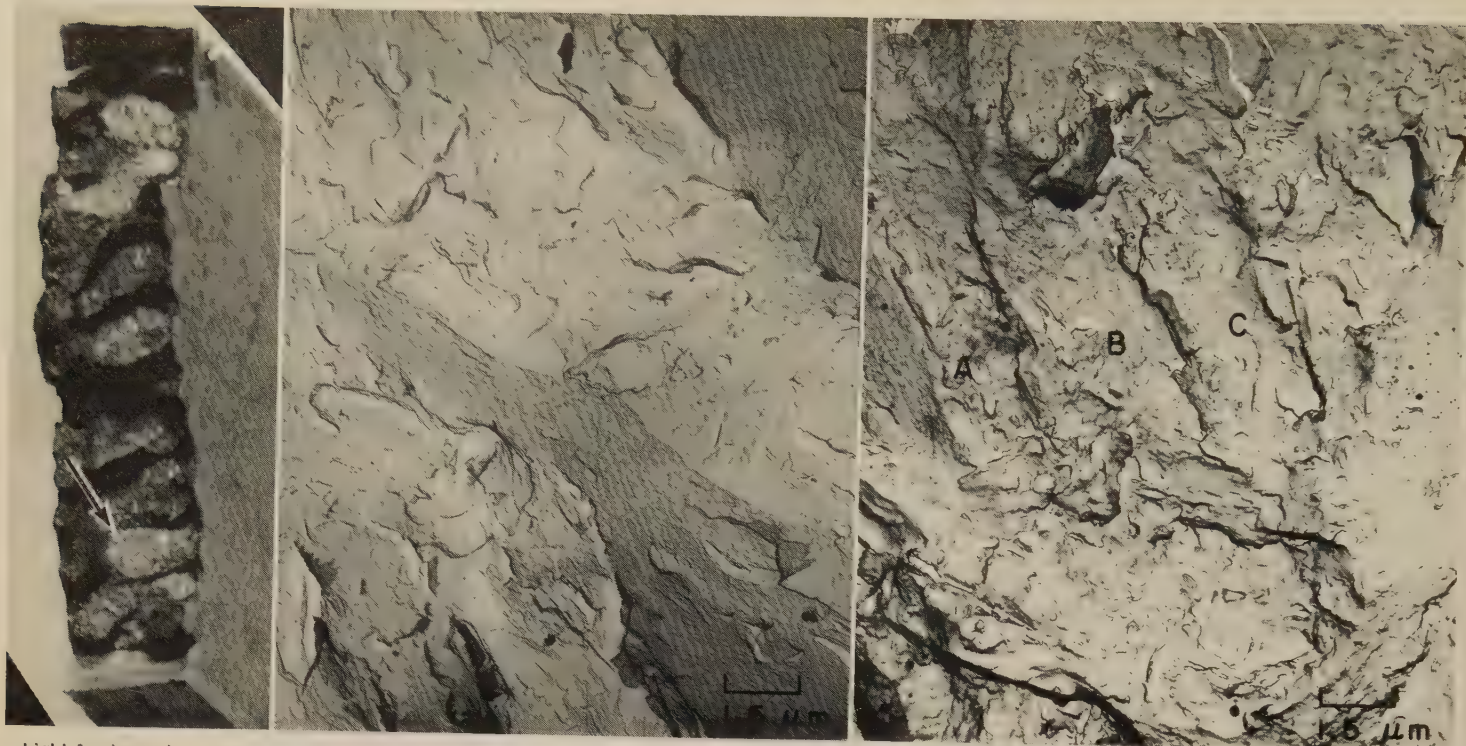
4341, 4342, 4343

Light fractograph 14× TEM fractograph (p-c replica) 6500×

Fractograph 4341 (left) shows a fracture surface in a specimen of 4340 steel sheet that was heat treated at 843 C (1550 F), oil quenched, tempered at 482 C (900 F), cathodically charged with hydrogen, and broken in loading to a stress of 689 MPa (100 ksi). The large facets of separated grains in 4341 display the intergranular nature of hydrogen-embrittlement fractures. The crack origin is not identifiable, but it is usually subsurface in fractures of this type. Two areas in the large facet at the arrow are shown in TEM fractographs 4342 (center) and 4343 (right). There is evidence also of quasicleavage in 4343, at A, B and C.

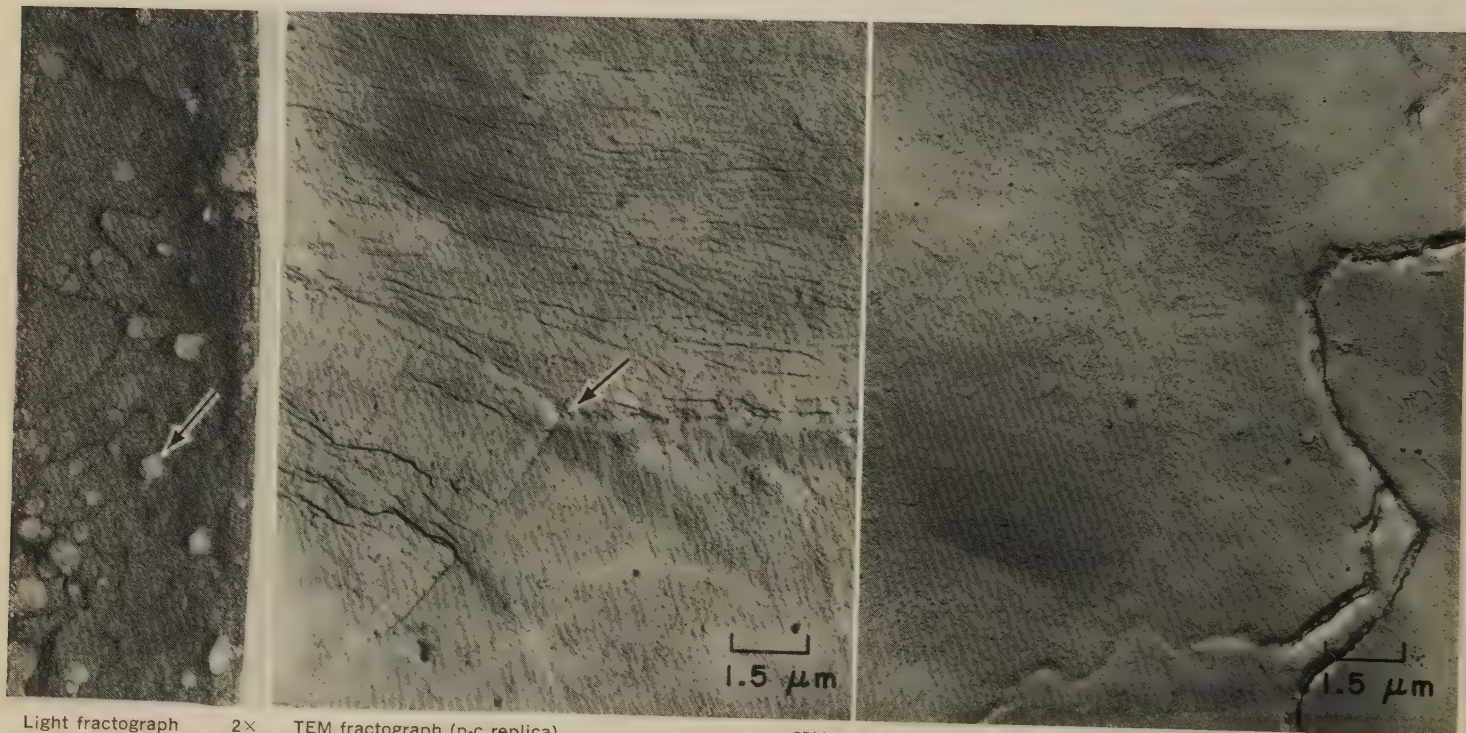
4344, 4345, 4346

Light fractograph 2× TEM fractograph (p-c replica) 6500×

Fractograph 4344 (left) shows a fracture surface in forged 4340 steel (heat treatment not reported), displaying the flat, bright, fine-textured features known as hydrogen flakes or fisheyes. Two areas in the flake at the arrow are shown in TEM fractographs 4345 (center) and 4346 (right). The surface in 4345 is flat and displays a fine, rippled texture that may have been caused by fracture of lamellae of fine pearlite. The speckled appearance may have been caused by corrosion products. The ridges, which may be grain boundaries, form a junction at the arrow. The surface in 4346 is remarkably smooth, with unusual "worm track" marks. The forked ridge at lower right is a deep fault or rift, probably the result of a structural discontinuity.

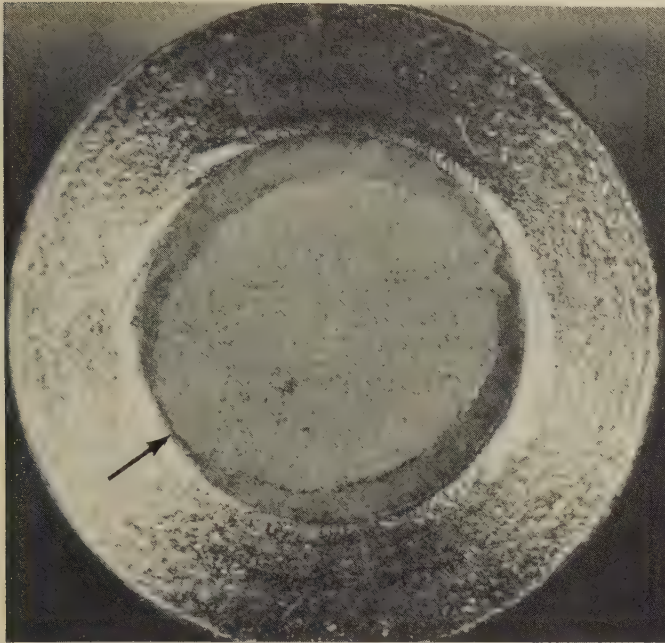
Light fractograph

4347 Surface of a sustained-load fracture in a hydrogen-embrittled notched specimen of 4340 steel with tensile strength of 1793 to 1931 MPa (260 to 280 ksi). This type of fracture can result from absorption of too much hydrogen from either acid pickling or metal plating. Area near the crack origin (at arrow) is shown in 4348.

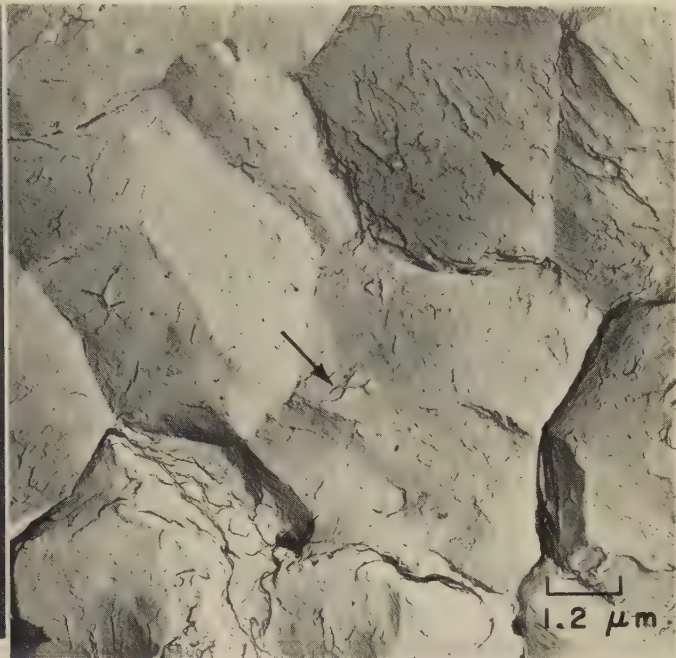
TEM fractograph (p-c replica)

4348 A TEM replica of the fracture surface in 4347, showing the area near the crack origin. This area displays the intergranular facets that are characteristic of hydrogen embrittlement. The hairline indications (at arrows) serve to distinguish this type of fracture from others.

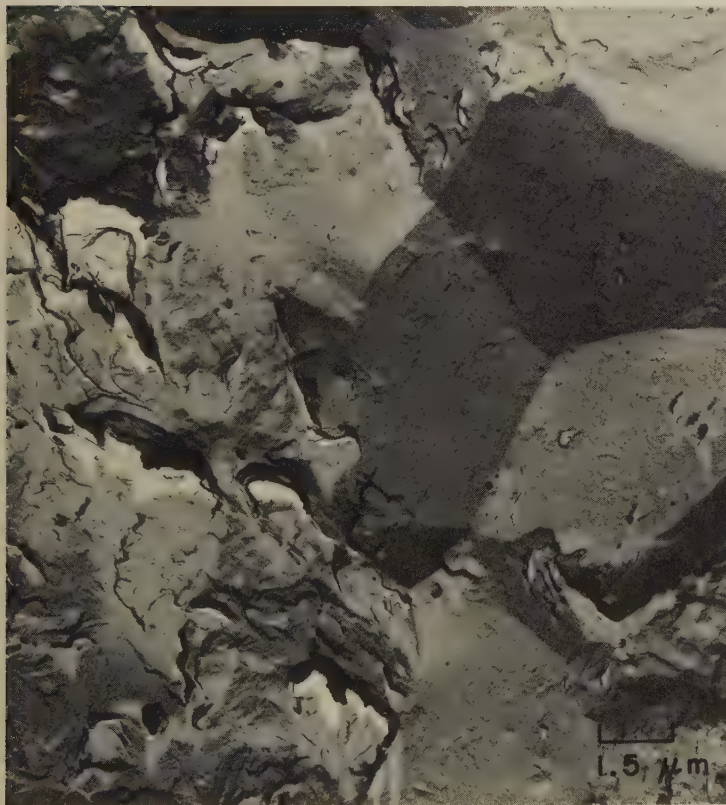
TEM fractograph (p-c replica)

4349 Surface of a crack discovered beneath chromium plating on an aircraft main-landing-gear cylinder of 4340 steel having a tensile strength of 1793 to 1931 MPa (260 to 280 ksi). Mainly intergranular in nature, the crack is attributed to hydrogen embrittlement, perhaps as a result of the plating.

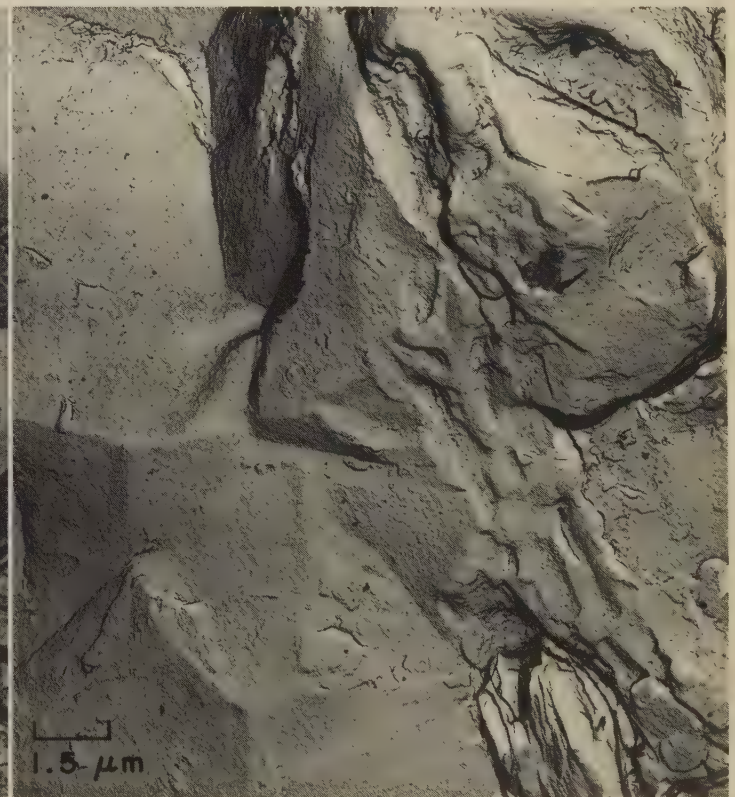
TEM fractograph (p-c replica)

4350 Surface of a crack that was found in an aircraft nose-landing-gear cylinder made of 4340 steel having a tensile strength of 1793 to 1931 MPa (260 to 280 ksi). The crack originated by stress corrosion at a region of concentrated nonmetallic inclusions beneath a discontinuous chromium plate.

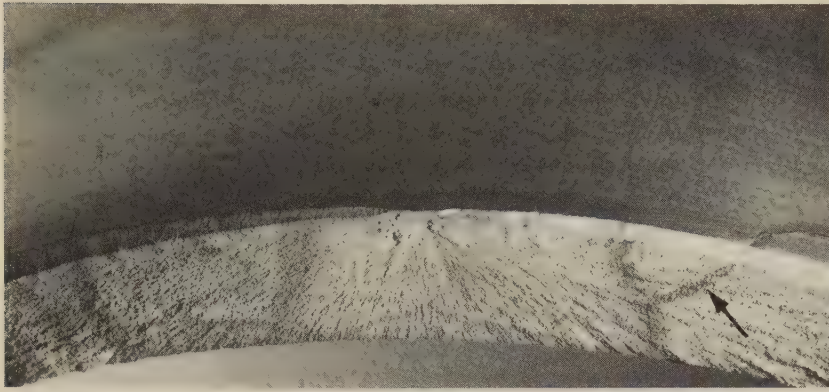
4351 Surface of a low-cycle fatigue fracture in an aircraft landing-gear cylinder made of 4340 steel that was hardened and tempered to a tensile strength of 1793 to 1931 MPa (260 to 280 ksi). The cylinder was stressed in the laboratory to its tensile strength four times and broke at a stress of 1103 MPa (160 ksi) during the final loading. Note the secondary crack (arrow) to the right of the crack origin (at center), representative of many that extended completely through the wall of the cylinder. See also 4352 to 4355.

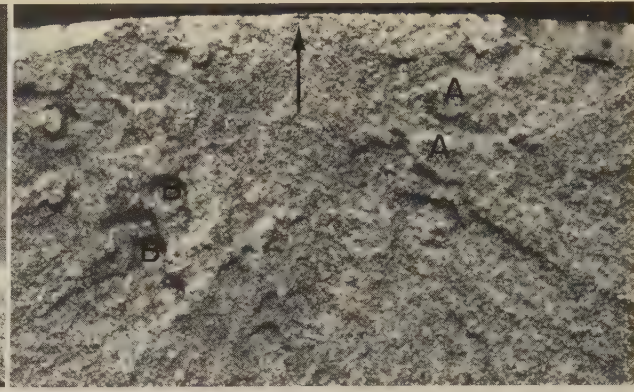
4352 Higher-magnification view of the crack-origin area of the fracture surface in 4351. Fracture originated at a small surface crack (visible at arrow) that was present prior to testing. The small flat-topped projections (at A's) and flat-bottomed depressions (at B's) were not found elsewhere in the fracture surface. See also fractographs 4353 to 4355.

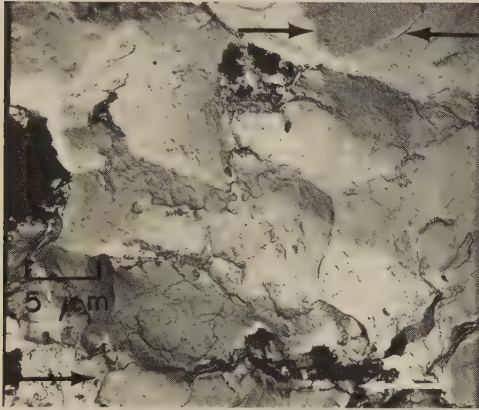
4353 TEM replica of a portion of the surface crack in 4352, where fracture originated. Note rubbed areas between arrows. The facets are intergranular; the opaque particles lie 0.002 to 0.003 in. below the outer surface of the cylinder.

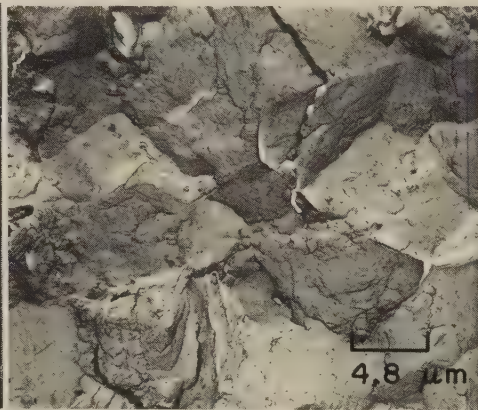
4354 TEM replica of the fracture surface in 4352, showing a region 0.01 in. below the outer surface. The mixture of intergranular facets and dimples shown here is typical of some plane-strain fracture surfaces in 4340 steel.

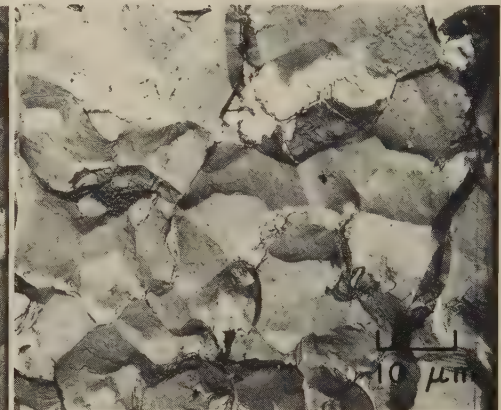
4355 TEM replica of the fracture surface in 4352, showing a region at the bottom of a depression directly below the surface crack. In this entire area of projections and depressions (see 4352), fracture was completely intergranular.

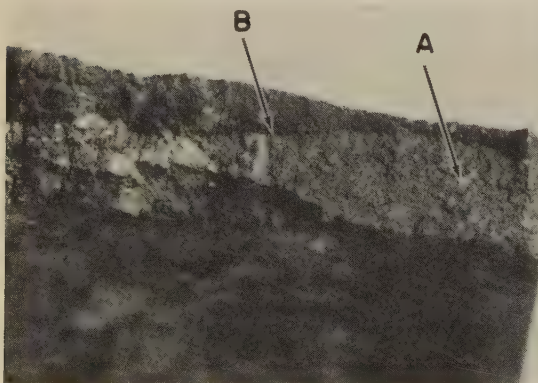
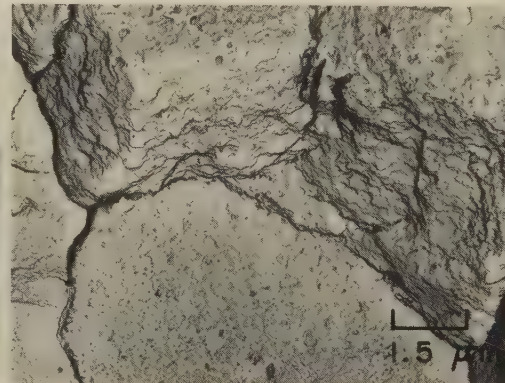
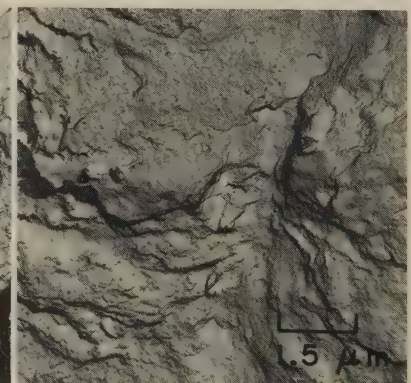
4356, 4357, 4358

Surface of a fracture in 4340 steel sheet that was heat treated at 843 C (1550 F), oil quenched, and tempered at 232 C (450 F). The sheet was loaded to a stress of 1241 MPa (180 ksi) for 27 days in a marine atmosphere and broke as the result of stress corrosion. Fractograph 4356 (left) is a low-magnification view of the entire fracture surface. Stress-corrosion cracking began at the right edge and produced the flat, tongue-shaped area marked A; at B, cracking changed to fast fracture and produced shear lips. Two regions in the area marked A in 4356 are shown at higher magnification in TEM fractographs 4357 (center) and 4358 (right). The facets in 4357 are clearly intergranular and carry an accumulation of corrosion products; this surface is fairly typical of stress-corrosion cracking. The facets in 4358 are too severely corroded for positive identification but probably are intergranular. See also 4359 to 4361.

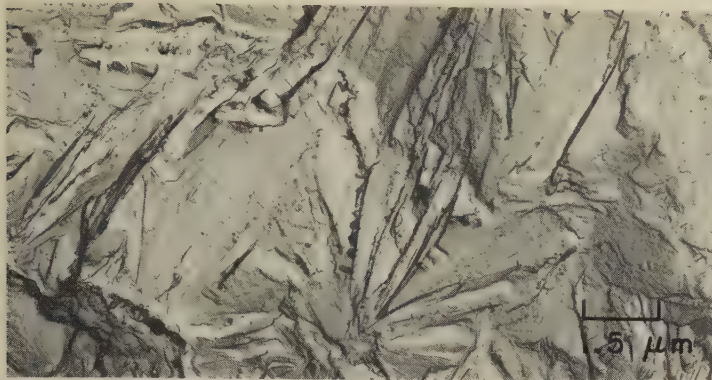
4359 TEM view of another region in the area marked A in 4356. The intergranular facets here carry a complicated array of corrosion products; in some areas, the corrosion products appear to have spalled during rupture.

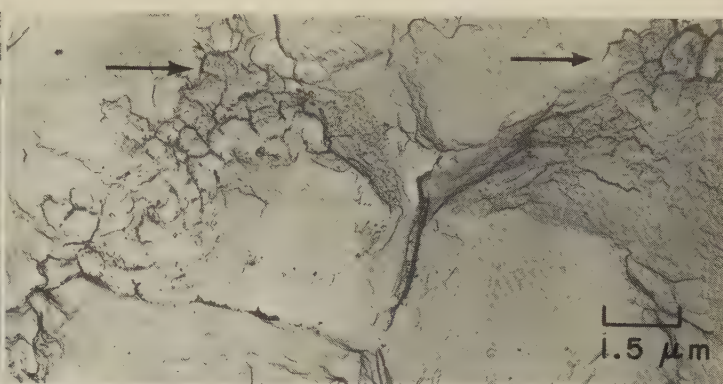
4360 TEM view of still another region in the area marked A in 4356. In addition to intergranular facets, this view shows, in the regions denoted by arrows (near top), another characteristic of stress-corrosion cracking — namely, “mud cracking”.

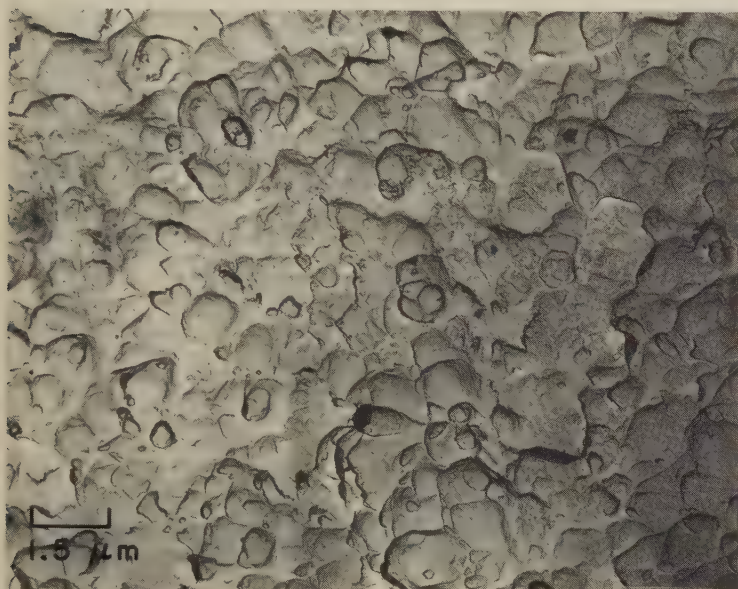
4361 TEM view of a portion of the fast-fracture region to the left of the area marked B in 4356. Shown here are equiaxed dimples, the presence of which indicates that microvoid coalescence occurred under tension overload following the increase in stress-intensity factor caused by growth of the stress-corrosion crack.

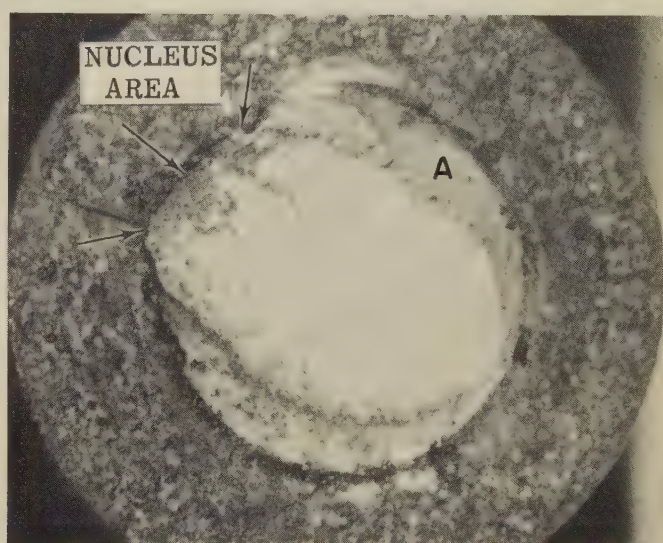
4362 Fracture in a notched specimen of 4340 steel oil quenched from 829 C (1525 F) and tempered at 232 C (450 F). The specimen was alternately exposed to deionized water (10 min) and to air (50 min) while being stressed at 800 MPa (116 ksi), and broke due to stress-corrosion cracking. Corroded perimeter is the notch surface. The region of final, fast fracture is at A. See also fractographs 4363 and 4364, below.

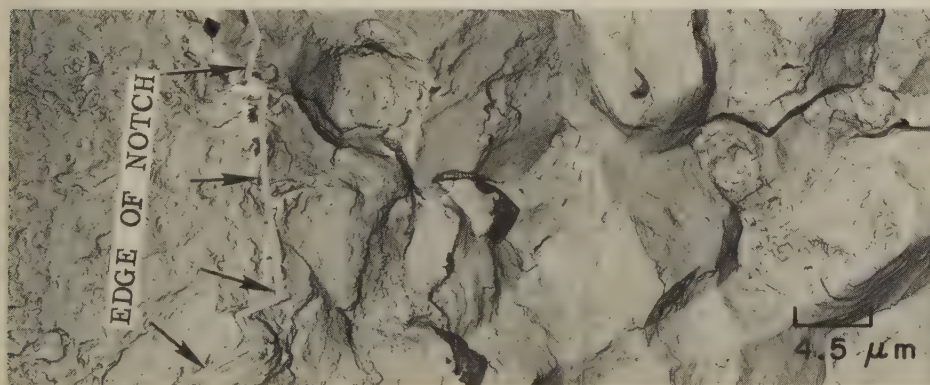
4363 TEM replica of a region in the crack-nucleation area in the fracture surface in 4362. Crack propagation was intergranular; the exposed grain facets are coated with corrosion products. Secondary cracks are visible at right. All cracks nucleated at, instead of below, the machined surface, regardless of notch sharpness.

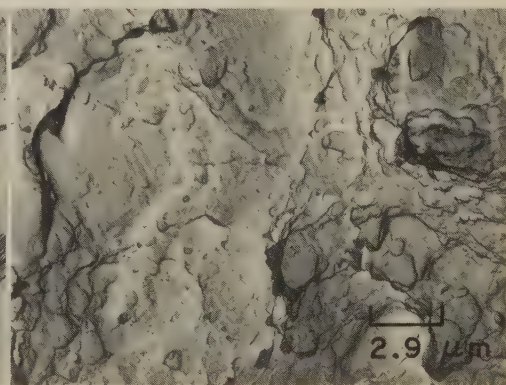
4364 TEM view of a portion of the fast-fracture region (A) of the stress-corrosion fracture surface in 4362. Shown here are dimples and suggestions of cleavage facets.

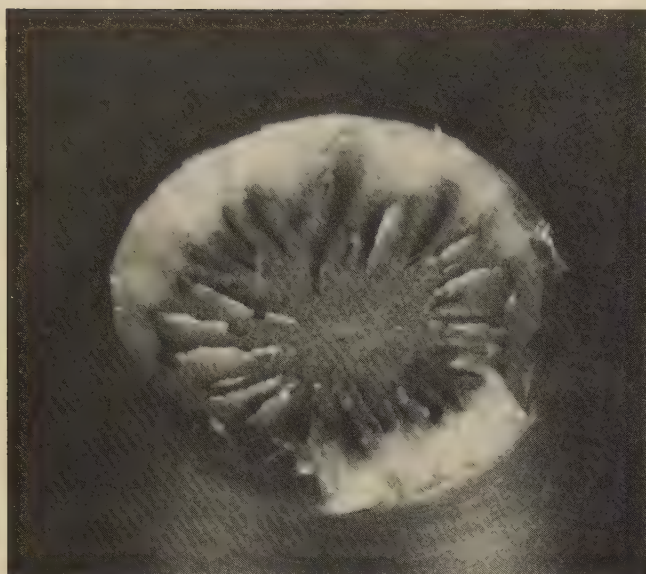
4365 Tension-overload fracture in an unnotched specimen of 8740 steel heat treated to a tensile strength of 1351 MPa (196 ksi); reduction in area, 52%. Note pronounced radial shear marks between central fibrous zone and outer shear lip in this otherwise conventional cup-and-cone fracture surface. See fractographs 4366 to 4368.

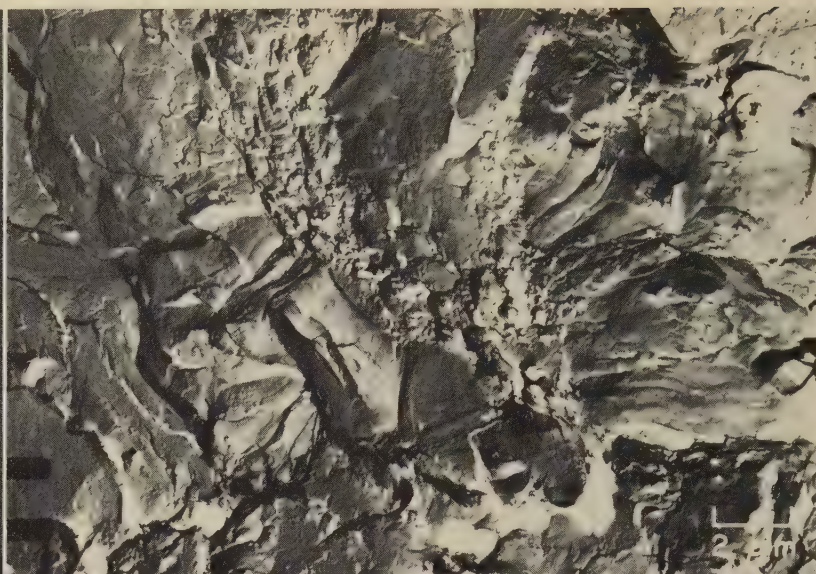
4366 TEM replica of an area in the central fibrous zone of the fracture surface in 4365, taken as close as possible to the radial shear marks. The surface contains dimples, in a wide range of sizes, that resulted from microvoid coalescence. There appear to be cleavage facets just below center, and below these facets there is a region with surface characteristics that suggest local quasicleavage. Note secondary cracks.

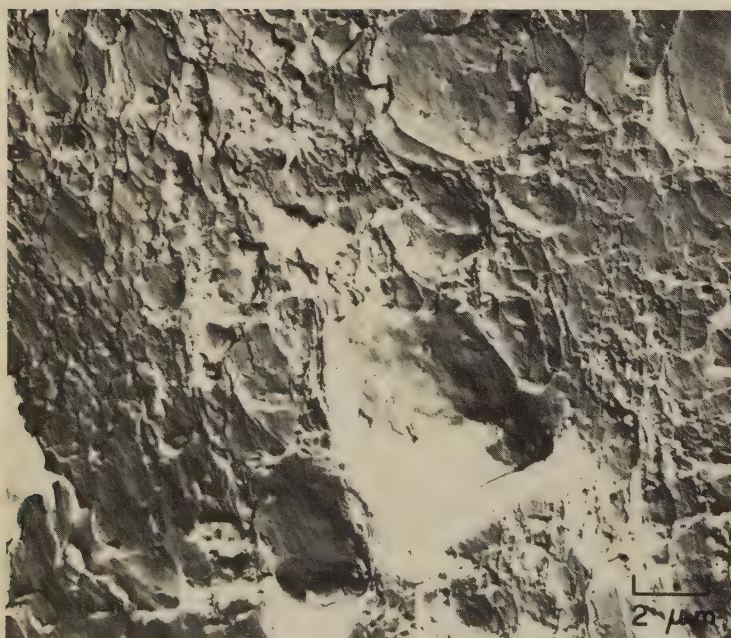
4367 TEM replica of another area close to the radial shear marks in the fracture surface in 4365. Here, a large number of flat shear dimples are interspersed with a few large dimples. At bottom center is a feature that appears to be a facet of an isolated inclusion rather than a dimple.

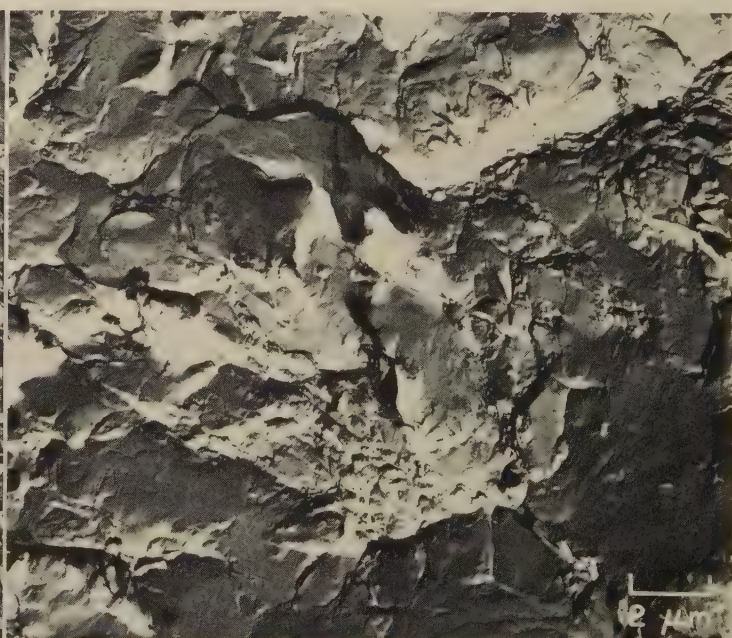
4368 TEM replica of a region of the fracture surface in 4365 near those shown in 4366 and 4367. As in 4366, secondary cracks are in evidence. Many of the very fine dimples visible here appear to have formed on the surfaces of larger dimples. Several of the larger facets at bottom appear to be quite flat.

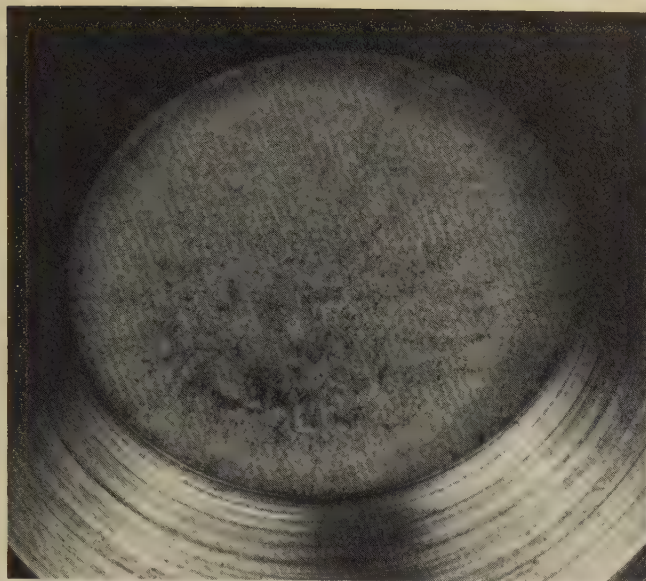
4369 Surface of a tension-overload fracture in a notched specimen of 8740 steel (same properties as in 4365). Notched tensile strength, 2044.3 MPa (296.5 ksi). In the unnotched specimen in 4365 (facing page), rupture began at center; here, the fracture origin was at the root of the notch. A fibrous zone surrounds a central radial fibrous zone. See also fractographs 4370 to 4372.

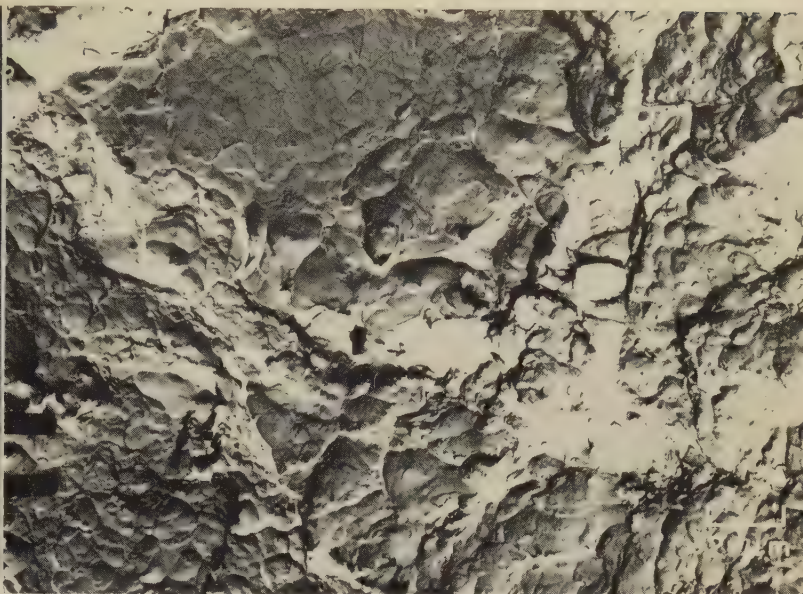
4370 TEM replica of a region in the central radial fibrous zone of the fracture surface in 4369, showing rather small, flat dimples that in general appear quite equiaxed. In an area near top and slightly to the left of center, the dimples are so flat as to present an almost smooth surface. This fracture surface appears to be relatively free of secondary cracks; a few minor ones can be seen at upper right and lower left.

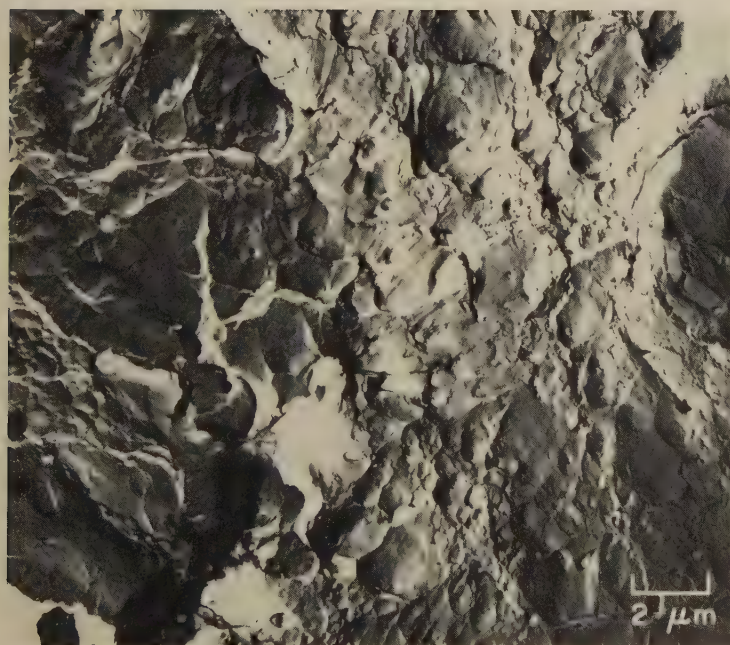
4371 TEM replica of another area in the central radial fibrous zone of the fracture surface in 4369. The dimples here are very similar to those in 4370. This area does not appear to contain secondary cracks or evidence of local cleavage; there are, however, several marks that are suggestive of tear ridges.
